## Analysis of a Laser-induced Instructions Replay Fault Model in a 32-bit Microcontroller

Vanthanh Khuat, Jean-Max Dutertre, Jean-Luc Danger

Vanthanh Khuat, Jean-Max Dutertre, Jean-Luc Danger. Analysis of a Laser-induced Instructions Replay Fault Model in a 32-bit Microcontroller. 2021 24th Euromicro Conference on Digital System Design (DSD), Sep 2021, Palermo, Italy. pp.363-370, 10.1109/DSD53832.2021.00061. hal-03433816

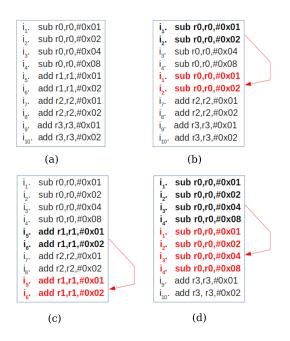
Figure 3. Test code and fault definition, (a) testcode, (b) replay  $i_1i_2$ , (c) replay  $i_5i_6$ , (d) replay  $i_1i_2i_3i_4$ .

The main part of our test code which consists of ten instructions is shown in Fig. 3(a). For convenience, the instructions are denoted as  $(i_1, i_2, i_3, i_4, i_5, i_6, i_7, i_8, i_9,$  $i_{10}$ ). As in cache disable mode, for every two clock cycles, 32-bit data corresponding to two 16-bit instructions are loaded from the Flash, the laser pulse was used to target the load of each two instructions. It should be pointed out that to differentiate the replay and skip of instructions, the replayed instructions shall not be no-operation (or nop instruction), because it would make the replay being equivalent to skip of instructions. Here, for convenience of post processing, instructions: sub r0, r0, #value (with value being  $0 \times 01$ ,  $0 \times 02$ ,  $0 \times 04$ ,  $0 \times 08$ ) were used for  $(i_1, i_2, i_3, i_4)$ ; and  $(i_5, i_6, i_7, i_8, i_9, i_{10})$  are simply the operations to add #value to a register, with value being 0x01 and 0x02. The initial values of the related register are as follows: R0:0x7F8000FF, R1:0x01FE0000, R2:0x3FC00000, R3:0x001FE000. And the expected values of the related registers at the end of the program are: R0:0x7F8000F0, R1:0x01FE0003, R2:0x3FC00003, R3:0x001FE003. The following fault definitions are used in this paper.

replay i<sub>1</sub>i<sub>2</sub>: (i<sub>5</sub>, i<sub>6</sub>) being overwritten by (i<sub>1</sub>, i<sub>2</sub>) as shown in Fig. 3 (b). In this case, the final values of the related registers are: R0:0x7F8000ed, R1:0x01FE0000, R2:0x3FC00003, R3:0x001FE003;

- replay  $i_{10}$ ) being overwritten by  $(i_9,$ 3  $i_6$ shown in Fig. (c). this  $(i_5,$ as the final values of the case, related registers are: R0:0x7F8000F0, R1:0x01FE0006, R2:0x3FC00003, R3:0x001FE000;
- **replay**  $i_1i_2i_3i_4$ :  $(i_5, i_6, i_7, i_8)$  being overwritten by  $(i_1, i_2, i_3, i_4)$  as shown in Fig. 3 (d). In this case, the final values of the related registers are: R0:0x7F8000E1, R1:0x01FE0000, R2:0x3FC00000, R3:0x001FE003;
- other: Instruction(s) modification, system faults, and other.

It is worth noting (as reported in section III) that in replay of two instructions:  $(i_5, i_6)$  are overwritten by  $(i_1, i_2)$  but  $(i_3, i_4)$  which are right above them, can not be replayed. While in replay  $i_1i_2i_3i_4$ ,  $(i_5, i_6, i_7, i_8)$  are overwritten by  $(i_1, i_2, i_3, i_4)$ .

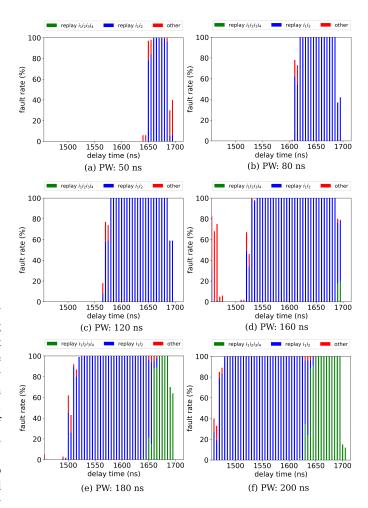
Figure 5. Obtained replay fault models and fault rates for laser PW set to: (a) 50 ns, (b) 80 ns, (c) 120 ns, (d) 160 ns, (e) 180 ns, (f) 200 ns.

The laser power was set to  $0.75~\rm W$ , the PW was set to different values from 50 ns to 200 ns. LFI delay was adjusted to target the loads of  $(i_5, i_6)$  and  $(i_7, i_8)$  from Flash memory by changing the pulse delay time. The obtained replay fault rates are shown in Fig. 5. First, we can see that the fault sensitivity window is proportional to the laser PW and that it ends around a delay time of 1,695 ns for each value of PW. For PWs of 50 ns, 80 ns and 120 ns, a replay of two instructions with a fault rate of 100% is observed, as shown in Fig. 5(a), (b) and (c). Starting from a PW of 160 ns, a replay of four instructions is seen at the end of the fault interval as shown in Fig. 5(d). Then, as the laser PW increases, the replay of four instructions interval widens accordingly as shown in Fig. 5(e) and (f).

As the clock period is approximately 83.3 ns, the replay of four instructions fault model  $(i_1, i_2, i_3, i_4)$  starts to appear as the laser PW reaches two clock cycles (i.e. 160 ns). The replay  $(i_3, i_4)$  fault model was never observed, it is only faulted together with  $(i_1, i_2)$ .

For analysis purposes, we drew the scenarios of replay faults in Fig. 6 where we depicted the sensitivity window of the replay  $(i_1, i_2)$  and  $(i_3, i_4)$  fault models with green arrows marked load buffer 1 and 2 respectively. For  $(i_1, i_2)$  as long as the pulse covers the first sensitive point, a replay of these two instructions is observed as shown in Fig. 6(a). Note that the delay sensitivity window in Fig. 5 (a) to (d)

extends leftward as the laser PW increases; this is because a greater PW accommodates with a lower delay to obtain a laser perturbation able to reach the instruction load process at 1,700 ns.

Fig. 7(d) illustrates the case of a longer laser pulse (corresponding to a laser PW greater or equal to 160 ns as reported in Fig. 5(e) and (f)) induced during clock cycles 2 to 4 and able to cover the sensitivity windows of both buffer 1 and buffer 2. As a result, the update of both buffers fails and a replay of four instructions is obtained (i.e. replay  $i_1i_2i_3i_4$ ). Our experiments did not revealed why it is impossible to replay instructions ( $i_3$ ,  $i_4$ ) independently of instructions ( $i_1$ ,  $i_2$ ). It is probably due to the hardware architecture of buffers 1 and 2 that is unknown to us and to the local effect of LFI.

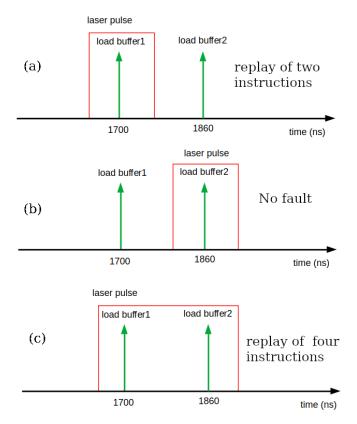
Figure 6. Different replay fault scenarios with different PWs and delay time, (a) replay  $i_1i_2$ , (b) nofault, (c) replay  $i_1i_2i_3i_4$ .

$(i_3, i_4)$  can not be replayed independently as illustrated in Fig 6 (b). However, as the pulse duration is long enough to cover both sensitive points at 1,700 ns and 1,860 ns, a replay  $i_1i_2i_3i_4$  is observed as exemplified in Fig. 6(c), which corresponds to the experimental results reported in Fig. 5 (e) and (f).

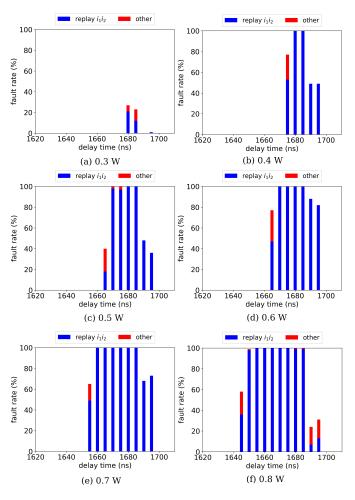
Figure 9. Impact of laser power on replay fault rate as PW is 50 ns, (a) 0.3 W, (b) 0.4 W, (c) 0.5 W, (d) 0.6 W, (e) 0.7 W, (f) 0.8 W.

To understand the impact of the laser power on the fault rate of the replay fault model, we set the PW at 50 ns and the laser power was progressively increased from 0.1  $\,\rm W$  to 0.8  $\,\rm W$  with an increment of 0.1  $\,\rm W$ . The corresponding fault rates are shown in Fig. 9. For laser power of 0.1  $\,\rm W$  and 0.2  $\,\rm W$ , no fault is detected. With the power of 0.3  $\,\rm W$ , replay  $i_1i_2$  is observed, however the maximum fault rate is only 20% and the fault sensitivity window is very small as shown in Fig. 9(a). Starting from laser power of 0.4  $\,\rm W$ , the fault rate can reach up to 100% as shown in Fig. 9(b). As the power goes higher, the fault interval becomes wider as shown in Fig. 9 (c), (d), (e) and (f). As can be seen, the laser power has a direct impact on the replay fault rate, it should be high enough to cause the replay fault.

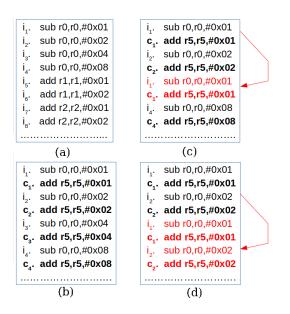
Figure 12. Detection of replay fault model (a) test code , (b) protected code, (c) replay of two instruction with protected code, (d) replay of four instructions with protected code.

We also developed a method to detect the LFI-induced instructions replay fault in a MCU. Fig. 12 illustrates the implementation of the method and its principle. Here, we consider the case of a replay that targets the block of instructions  $(i_1, i_2, i_3, i_4)$ , see in Fig. 12(a). The idea behind this method is to insert a hardware counter (register R5 in our case) to be incremented after each instruction and use it to detect the fault as highlighted in bold in Fig. 12(b). R5 is used as the counter, and the inserted instructions are denoted as  $(c_1, c_2,$  $c_3$ ,  $c_4$ ), which are simple add operations. Notice that each time the counter is incremented with a different value using instruction add R5, R5, #value with the value being  $0 \times 01$ ,  $0 \times 02$ ,  $0 \times 04$ ,  $0 \times 08$ . Fig. 12(c) demonstrates the case in which replay fault happens with two instructions  $(i_1, c_1)$ . While Fig. 12(d) demonstrate the case in which replay fault happens with four instructions  $(i_1, c_1, i_2, c_2)$ .

As a consequence of the laser-induced instructions replay, the value of R5 will be modified. Therefore, in the program by checking the value of R5, the fault can be detected. For example, consider that an initial value of R5 is  $0 \times 00$ . At the end of the program, the expected value of R5 is  $0 \times 0$ F. However, if the replay of two instructions illustrated in Fig. 10(c) happens,  $(i_3, c_3)$  are overwritten by  $(i_1, c_1)$ , and as a result the value of R5 would be  $0 \times 0$ C. In case of a replay

of four instructions as illustrated in Fig. 10(c) (where  $(i_3, c_3, i_3, c_4)$  are overwritten by  $(i_1, c_1, i_2, c_2)$ ), the value of R5 would be  $0 \times 0.6$  which would be detected.

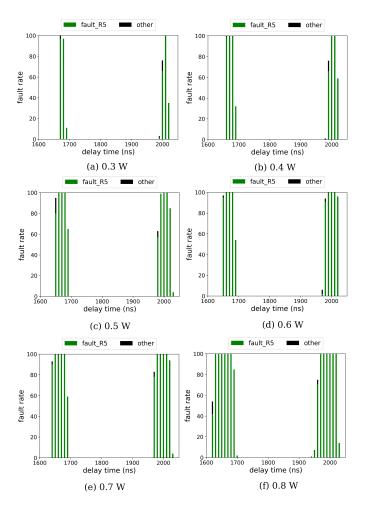
Figure 13. Experimental result using a hardware counter to detect replay fault, PW 50 ns (a) 0.3  $\rm W$ , (b) 0.4  $\rm W$ , (c) 0.5  $\rm W$ , (d) 0.6  $\rm W$ , (e) 0.7  $\rm W$ , (f) 0.8  $\rm W$ .

We experimentally tested this method against LFI-induced replay instructions faults. In the following, in order to evaluate the effectiveness of the detection method, the detected faults are classified into fault in R5 (i.e. a replay fault is detected thank to an incorrect value readback from R5) and other fault (fault occurs without affecting value of R5). The results obtained with different laser powers, while the PW was 50 ns are shown in Fig. 13. It can be seen that in most of the cases where faults occur, the value of R5 is also faulted. No replay fault was observed without being detected by a faulty value of R5. The proposed method was proved to be effective at detecting laser-induced replay faults with a 100% success rate. It should be pointed out that the detection method only works if one of the instructions  $c_n$  (with n being 1, 2, ...) is included in the block being replayed or overwritten. In case of single instruction updating, if the laser illumination prevents updating the instruction  $i_n$  but does not prevent updating the counter  $c_n$ , the replay will be not detected because the value of the counter is correct.
